## EAST AFRICAN COMMUNITY LAKE VICTORIA BASIN COMMISSION

# IDENTIFICATION AND MAPPING OF ECOLOGICALLY SENSITIVE AREAS (ESAS) IN LAKE VICTORIA

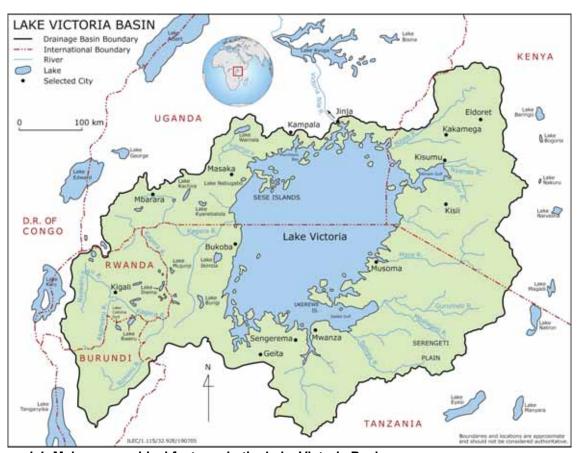
Figure 1.1. Main geographical features in the Lake Victoria Basin

Lake Victoria (surface area: 68,000km²), located in the central region of East Africa, has a catchment covering an area of 194,000 km² (7% is in Burundi, 22% in Kenya, 11% in Rwanda, 44% in Tanzania and 16% in Uganda). The lake, which is shared by Tanzania (51%), Uganda (43%) and Kenya (6%), is the most dominant geographical feature in the LVB. In comparison to the other Great Lakes of Africa (e.g. Tanganyika, Turkana and Nyasa), Lake Victoria is considered to be relatively young, formed

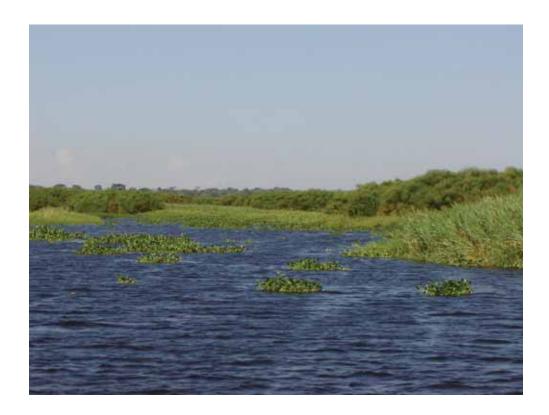
Plate 3.1. The dominant emergent wetland around Lake Victoria

A total of 422 wetlands (61 in Kenya, 219 in Uganda and 142 in Tanzania) were mapped in and around Lake Victoria (Figures 3.1 and 3.2). The total wetland area delineated was 4,322 km² of which 417 km² was in Kenya, 2,025 km² in Uganda and 1,880 km² in Tanzania. These wetlands were mainly emergent or swamp systems characterized by herbaceous and emergent vegetation such as Papyrus (*C. papyrus*), Reeds (*Phragmites* sp.) and Hippo grass (*V. cuspidata*) (Plate 3.1). The other wetlands around the lake included the shrub land systems dominated by evergreen shrubs (Plate 3.2). The largest coverage of wetland by area was mapped in Uganda while the smallest was in Kenya and this pattern corresponds with the proportion of shoreline lengths around the lake. The water regime varied among the mapped wetlands and included saturated, seasonally flooded and semi permanently flooded soils.

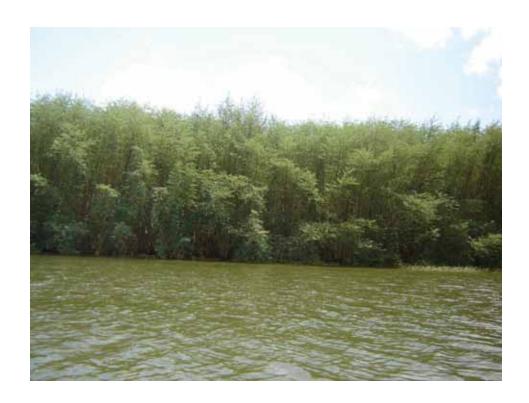
Plate 3.2. Shrub wetland around Lake Victoria dominated by Ambatch trees

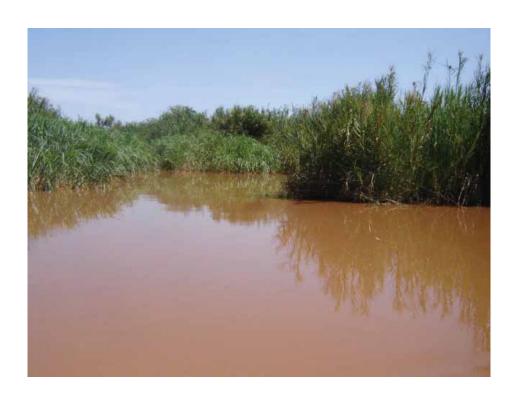
Plate 3.3. Turbidity of an open river mouth

A total of 66 river mouths (24 in Kenya; 22 in Uganda; and 20 in Tanzania) were mapped along Lake Victoria shoreline (Table 3.4 and Figure 3.10). The full list of river mouths and their levels of disturbance are indicated in Appendix VIII. The water clarity at river mouths ranged from very clear to very turbid depending on the river catchment activities (Plates 3.3 and 3.4).

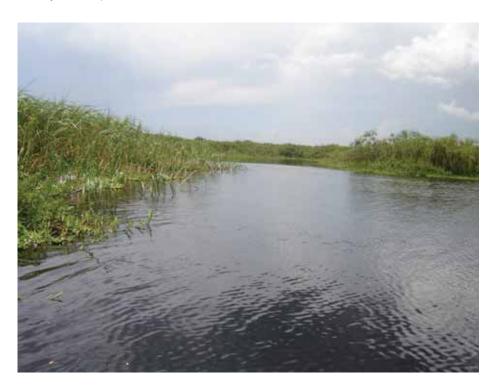
Plate 3.4. Clear waters of a densely vegetated river mouth with high buffering capacity

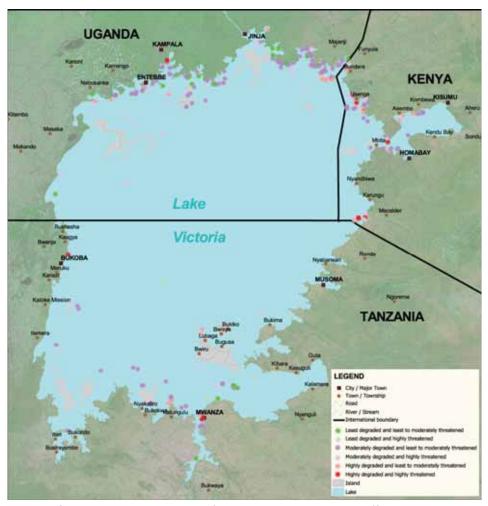
Figure 3.11 Status and distribution of rocky-outcrops under different sensitivity classes

A total of 239 rocky outcrops (57 in Kenya, 131 in Uganda and 51 in Tanzania) were mapped in Lake Victoria (Figures 3.11 & 3.12). The Highly degraded and Highly threatened rocky outcrops in Lake Victoria were 10 in Kenya, namely; Nyenye, Sirongo, Ugambe, Luorkana, Osope, Morache, Nyatike I, Sumba and Wikwang; 4 in Uganda, namely; Mpagi, Kamutenga and 2 small Mutungo, and Nakivubo; 3 in Tanzania, namely; Bismack, Bwiru point and Capri point (Appendix IX).

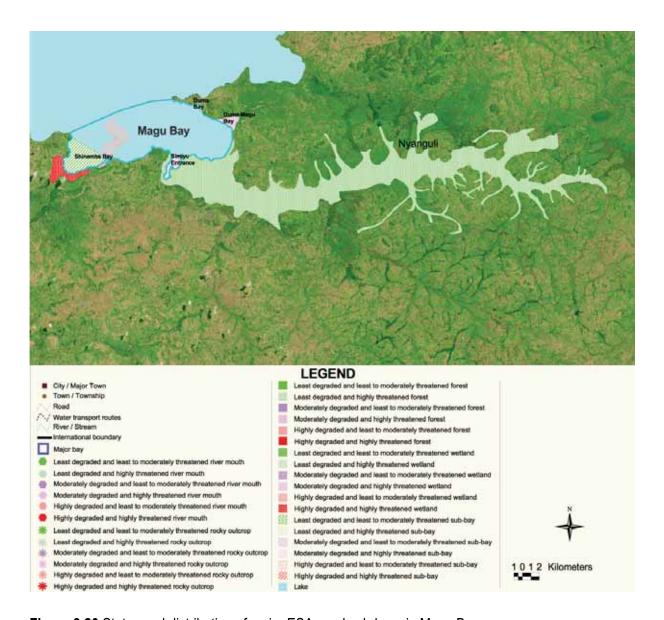
Figure 3.20 Status and distribution of major ESAs and sub-bays in Magu Bay

In Tanzania, Smith Sound Bay/Stuhlmann Sound Bay and Magu bay were considered. The sub-bays in the two major bays (Figure 3.19; 3.20) have diverse attributes including the presence of river mouths, wetlands, forests and rocky outcrops. The sub bays have different sensitivity levels ranging from 'Least degraded and least to moderately threatened sub-bays' sensitivity.

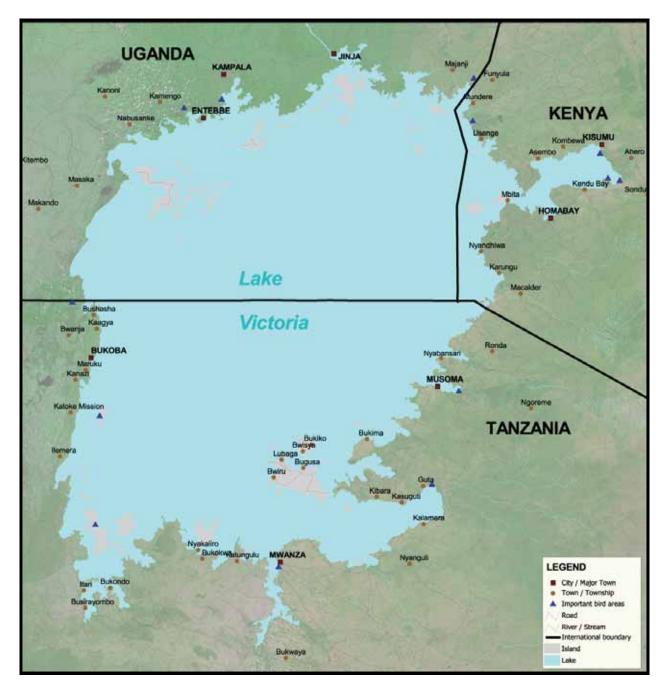
Figure 3.23 Mapped important bird areas (IBAs) around Lake Victoria

A total of 15 important bird areas were mapped in and around Lake Victoria (5 in Kenya, 4 in Uganda and 6 in Tanzania). Ten (10) of the IBAs are Ramsar sites (4 in Uganda and 6 in Tanzania) while the 5 in Kenya are not yet gazetted but are recommended Ramsar sites (Figure 3.23).

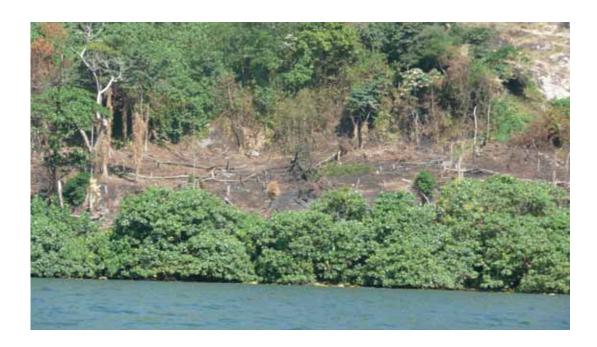
Plate 4.1. A lakeside forest being opened up for agriculture

Other threats to forests surrounding Lake Victoria include change of land use to commercial agriculture (Plate 4.1). For example on Bugala Island, Kalangala, Uganda large areas previously under natural forest have been converted into palm oil plantations that do not share all the ecological attributes of natural forest. Power lines and road construction projects also create wide corridors that can impact the integrity of forests and disrupt wildlife populations. However, the fundamental driver of deforestation around Lake Victoria is population growth.

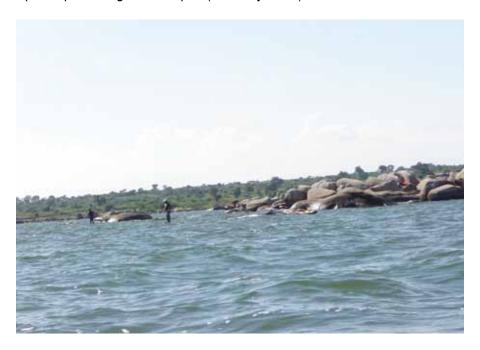
**Plate 4.2** Fishers catching rock dwelling haplochromines for use as bait in the Nile perch long line fishery

- (i) Change in water levels and siltation;
- (ii) The currently rampant practice of fishers collecting large numbers of rock dwelling haplochromines for ornamental practices and for bait in the Nile perch long line fishery (Plate 4.2). The matter is worsened by lack of sufficient information on lake wide distribution of such populations and species. Transfer of rock-restricted cichlids from one population to another could also result in hybridization and consequent loss of haplochromines species diversity;
- (iii) Disturbance of vegetation by fishermen anchoring to harvest fish using hook and line (angling) as well as surrounding the rocky outcrop with monofilament nets to catch fish which use rocky outcrops as refugia; and
- (iv) Invasive plant species e.g. *E. crassipes* (Water hyacinth).
