Fish Quality Assurance at Landing Beaches and During Transportation to Fish Processing Plants

John Makene
Nyegezi Freshwater Fisheries Institute, P.O. Box 1213, MWANZA, TANZANIA
Phone 028 2550119 Email nffi@raha.com

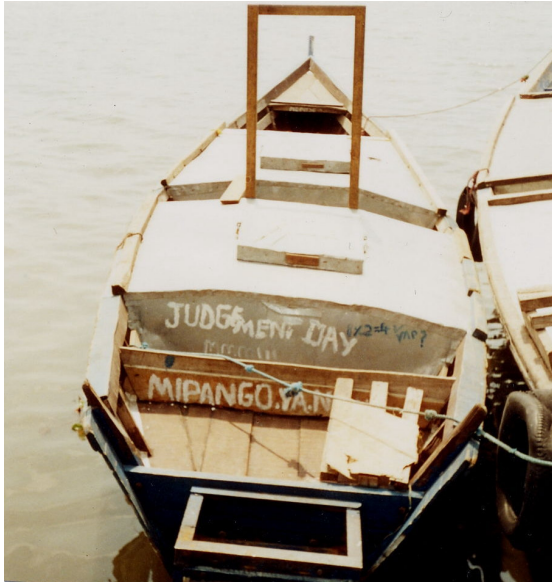
FIG. 1: Fish Collection Boat

To facilitate the transfer of fish from fishing boats to fish collection boats, all fish collection boats were advised to construct a Biped or Tripod stand on their boat for hanging weighing scales (Fig. 1) for weighing fish during sales. On arrival at the fishing villages/camps, fish collectors were advised to anchor their boats at a distance (5-10 meters) from the beach, away from the contaminated beach water. Fishing boats were advised to go along side the fish collection boats. A reserved area for fishermen to directly transfer good quality Nile perch into the fish collection boats was established.

In areas sheltered from waves and wind, the transfer of fish from fishing boat to fish collector's boat was easy and acceptable. Many Fish collectors preferred the system, as it simplified fish handling work. They easily assessed the quality, weighed and iced the fish in the insulated container on board. Fishermen then continued to the beach to sell the rejected fish.

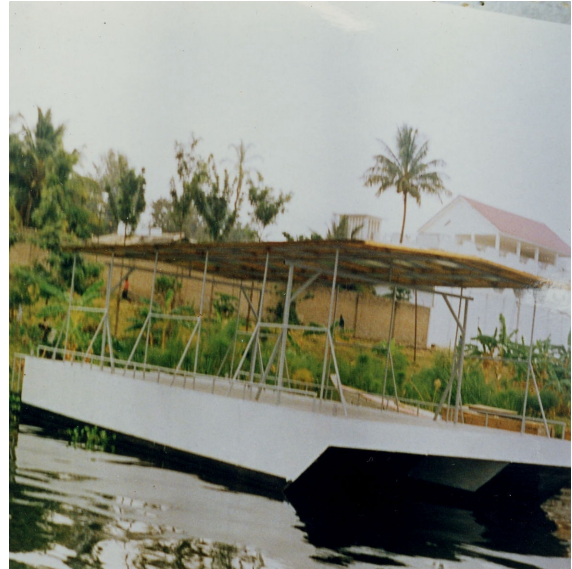
FIG. 2: Floating Barge

In designing the floating barge it was found that 12m x 5m x 1.2m was a suitable barge size, able to accommodate four fish collection boats at a time. Barges were constructed by Mwanza Boatyard and put in use as fish transfer platforms.

Fishing boats returning from fishing, go along one side of the barge, while fish collection boats operate on the other side. Four barges were made for Mihama, Ito, Nansio and Kayenze.

To eliminate beach contamination during fish landing, LVEMP introduced floating barges to be used as landing jetties. In designing the barges, the following parameters were taken into consideration: -

The use of the floating barge became a breakthrough in fish handling because clean fish, caught in clean deep waters, remained clean all the way to the fish processing plants.

The use of the barges however, had some shortcomings namely;

- Number of fish porters on the barge per fish trader were high, resulting in over crowding.
- A few fishermen had a tendency to remain on the barge after sales, increasing over crowding.
- Some fish traders/agents kept several insulated containers on the barge further reducing the available space.
- It was difficult to use the barge during strong winds.
- There was no provision of a portable water system for washing the barge and the fish handling facilities after use.

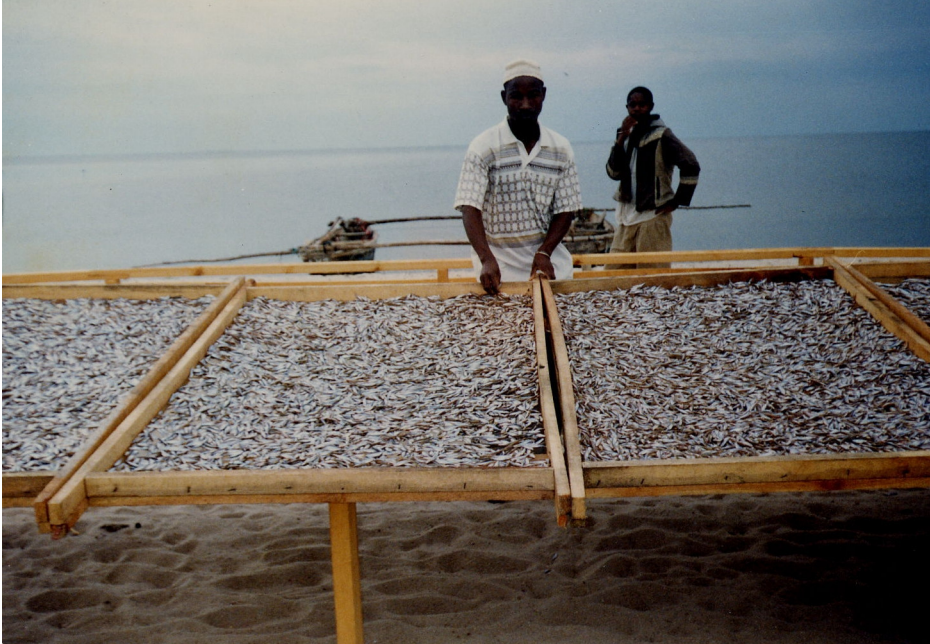
Figure 3: Drying Dagaa at Ntama Beach, Sengerema District

Work to improve hygienic practices concentrated on improving Dagaa processing techniques. Appropriate kilns and drying racks were constructed (Fig. 3) and drying techniques demonstrated.

Products from the racks (Fig. 3) proved to be of high quality, very clean, without sand and with shining colour. Most of the processed Dagaa remained round an attractive shape.
