Lake Victoria Environmental Management Project (LVEMP)

Survey and Mapping of Land Use/Cover and Erosion Hazard in Lake Victoria Basin

Final Report November 2001

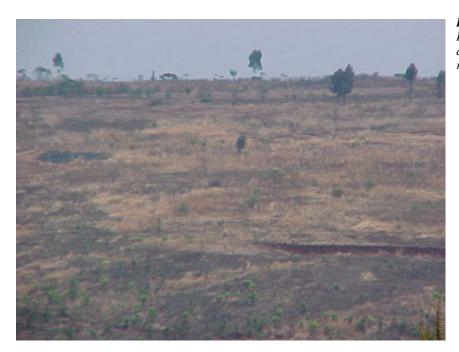
This situation gives an indication that more land has been opened up from woody vegetation to bare land or grassland as a result of refugee influx. Environmental implications of this ecological change is the exposure of soil to water and wind erosion as it was noted to be the case in some areas (see Photo 1).

Photo 1:Deforestation associated with refugee influx

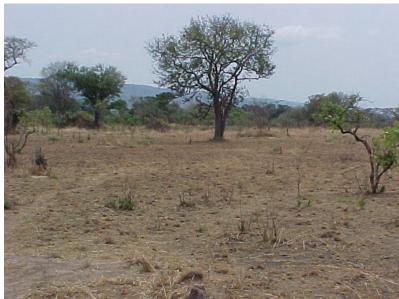
Agro-pastoralism is normally practiced on pediment slopes, footslopes, and on the seasonally inundated drainage depressions. Thus, except in reserved areas (including those under 'Ngitiri') where encroachment has not been severe, the natural vegetation of such locations has largely been replaced by cultivated crops or derived bush. The expansion of agriculture in areas that were traditionally used for grazing purposes has enhanced serious land use conflicts especially between agriculturalists and livestock keepers. The consequence of such conflicts is overgrazing in the reduced grazing areas leading to sheet and gully erosion. This situation is clearly evident in the eastern parts of Biharamulo District, Magu, Kwimba, Misungwi, Geita, Sengerema, Bunda and Tarime Districts (see Photo 2).

Photo 2: Overgrazing in part of Lake Victoria Basin

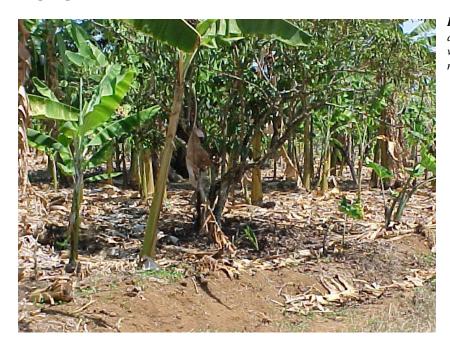
In Kagera Region, for example, the widely used practice of heavy mulching on the cultivated slopes appear to be very effective in controlling soil erosion caused by raindrop impact and surface wash (see Photo 3).

Photo 3: Mulching as an effective soil and water conservation measure

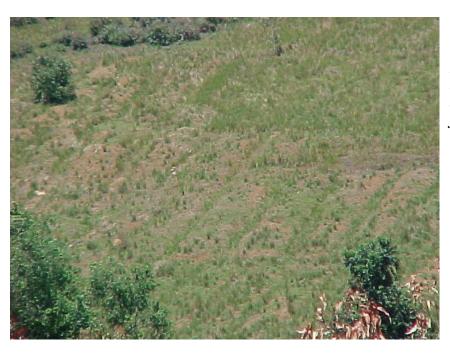
Different crops are managed differently. It was, for example, learned that banana and coffee are well managed in Kagera Region and in Tarime District (Mara Region). There are efforts to introduce coffee farming in Bunda and Serengeti Districts as well. In Kagera Region, there is an elaborate system of practising mulching in banana and coffee fields. Such a system enhances soil fertility and structure through the incorporation of organic matter into the soil. Furthermore, the system contributes to soil and water conservation. The soil is permanently covered with mulches and water infiltration is also enhanced as a result of improved soil structure. This was, however, not the case for Ngara District where people grow mainly maize, beans, bananas, and cassava on the plateau and hill slopes with limited soil and water conservation measures. There were evidence of sheet erosion in some places, particularly in cultivated fields, thus calling for introduction of soil and water conservation measures in the farm management. The area has high potential risk for soil degradation due to relief (mountainous terrain) and soil characteristics (erodible soil). It was, however, observed in some localities especially particularly in Bukoba District that some farmers make ridges along the slope on footslopes (see Photo 4).

Photo 4: Ridges along the slope direction on the footslopes

This seemed to be an environmentally unfriendly system. Explanations gathered concerning the system is that the soil is shallow and for crops to grow beds have to be raised. But also the fact that the shallow soils overly a hard pan, water infiltration is inhibited. For crops to grow, water has to be drained through furrows between the ridges.

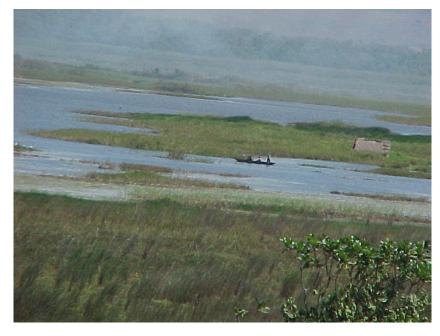
It was noted also that some wetlands are left out of human interference, thus making them function as trapping system of sediments eroded from the upland (see Photo 5). This was, however, not the case for Ngara District where valley bottoms are used for growing bananas and vegetables during the dry season, and along the lakeshores of Biharamulo, Geita, Sengerema and Bunda Districts where agricultural expansion and irrigation practices have reached the lakeshores. Such practices alter the hydrological functions of such wetlands.

Photo 5: Nondegraded wetlands functioning as trapping system of sediments eroded from the upland

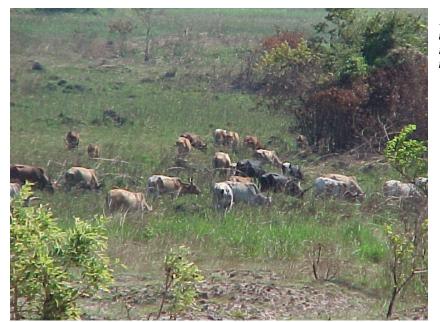
Livestock keeping is also practised to a limited extent in the banana and coffee growing areas in Kagera region. Grazing is mainly in the plains, which are not utilised for crop growing (see Photo 6). The environmental impact of livestock grazing seems to be limited in the area because grazing land is flat to gently sloping, thus making the area less susceptible to water erosion.

Photo 6: Grazing in the plains with minimum impact on the environment

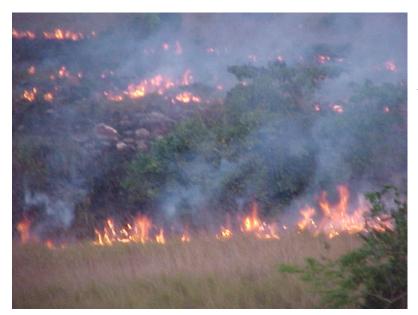
Photo 7: Burning as a potential environmental threat

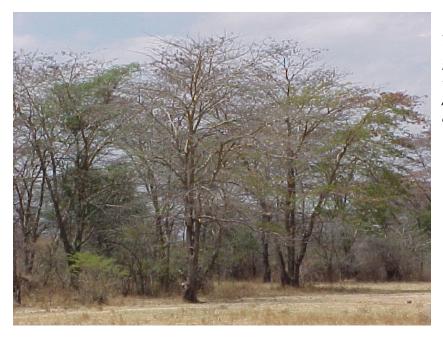
Few patches of intact vegetation were observed and these are traditionally managed woodlands/bushland known as *Ngitiri* (see Photo 8). It was learned that there are two levels of managing *Ngitiri*, at a community and household level. *Ngitiris* managed by the community are larger in size, while those managed by households are smaller, and often situated close to the homestead for effective management purposes. *Ngitiris* have an important function in such communities where woody vegetation is a scarce resource. They are therefore not only sources of fuelwood and building poles, but also, they perform the function of providing grazing land for oxen during ploughing period.

Photo 8: Traditionally managed woodlands /bushland known as Ngitiri

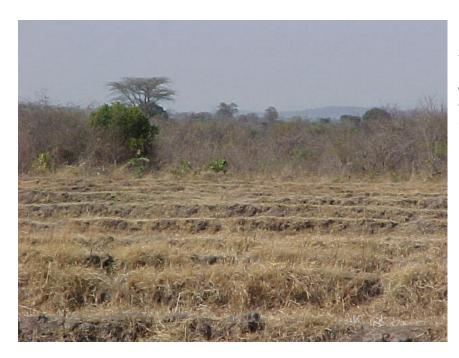
In Sukumaland, contour ridging and bunding are commonly used to check erosion caused by surface wash and as water conservation measure (see Photo 9). It is however, regretting to observe that the practice of tie-ridging which had proven to be most effective in water conservation and in preventing soil erosion is presently not as widely used on account of being too laborious.

Photo 9: Contour ridging and bunding commonly used in Sukumaland
